APPLICATION FOR A VARIANCE

TCLP LEAD TESTING

ASBESTOS SURVEY REPORT

94 MAIN STREET JACKSON, NH

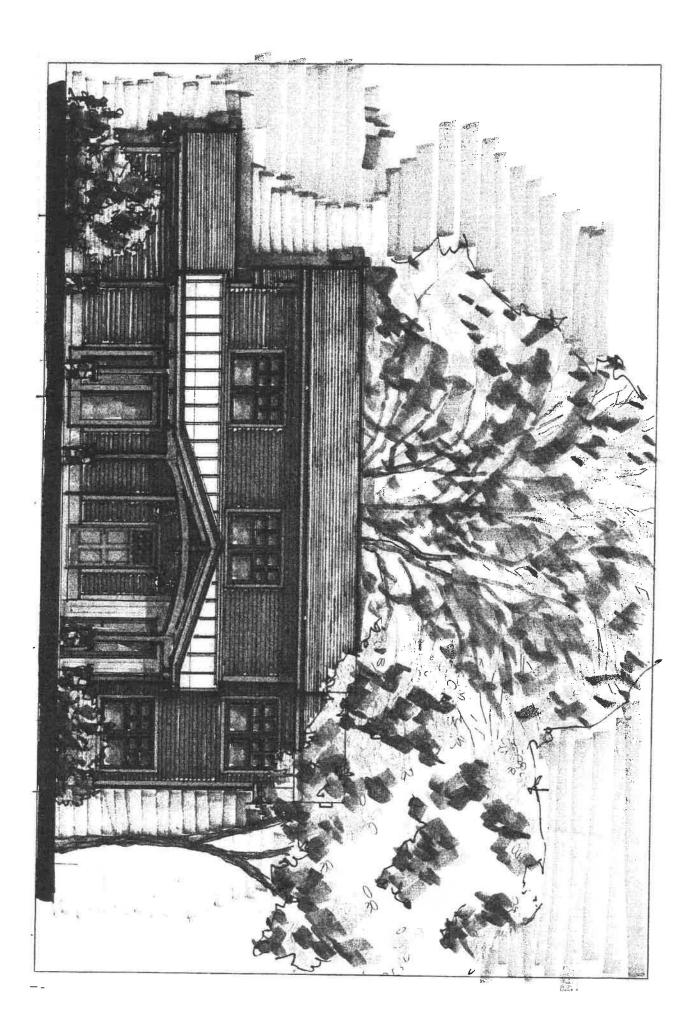
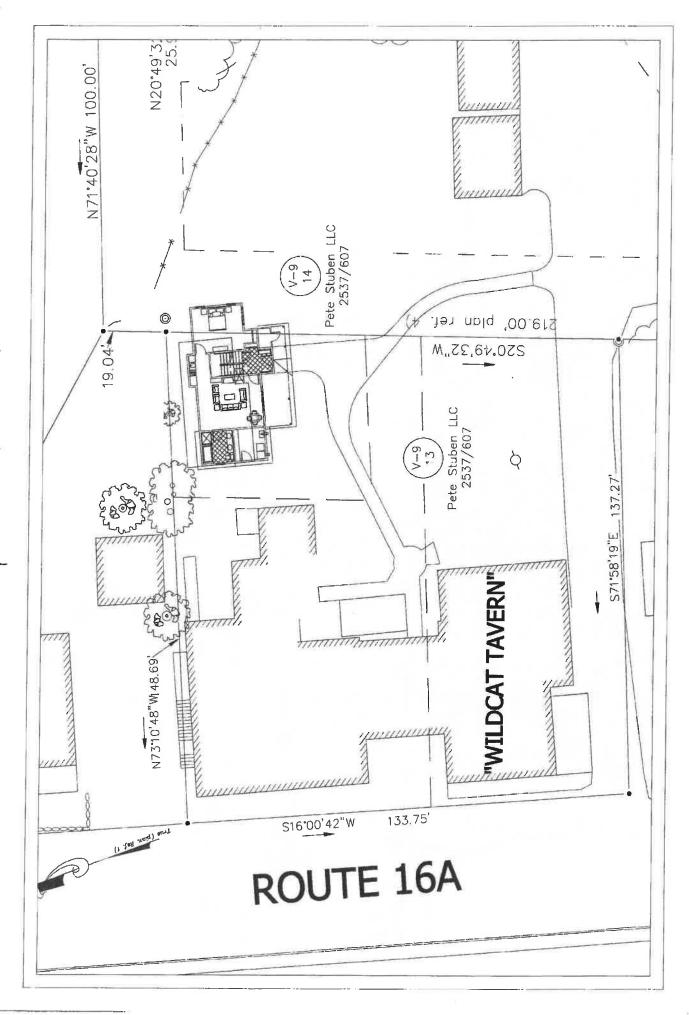
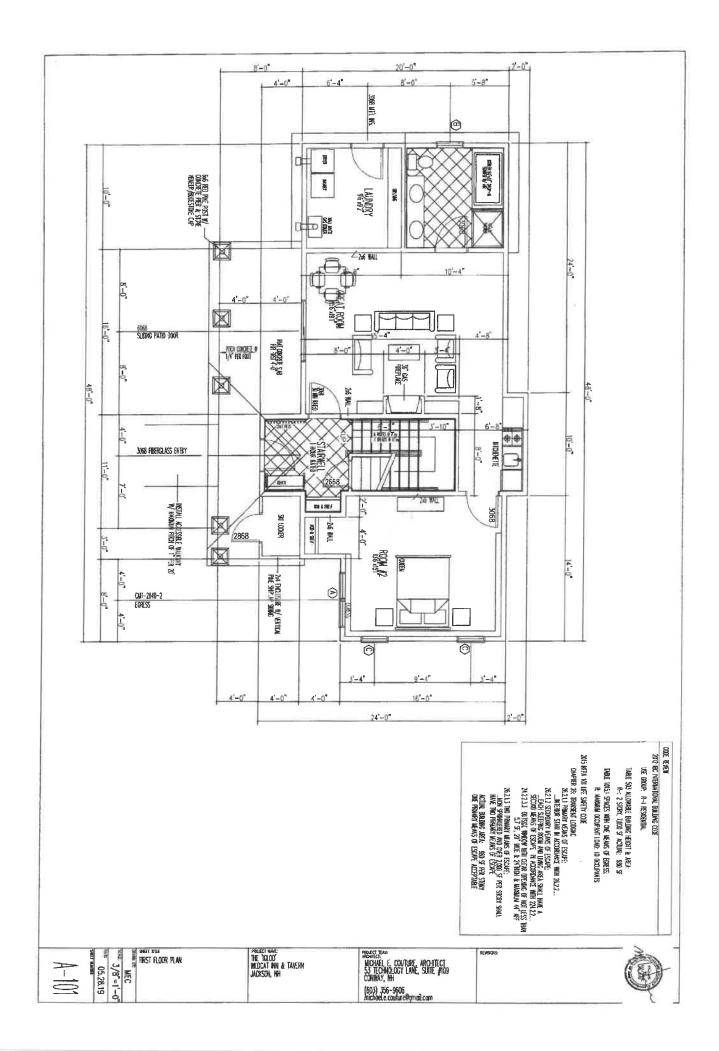
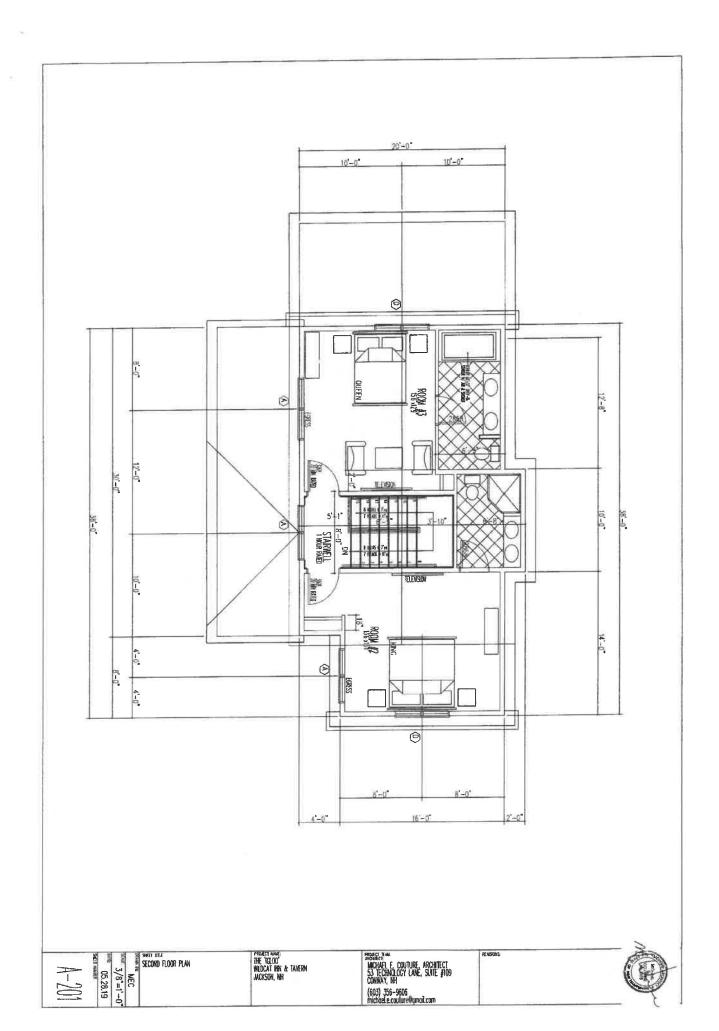
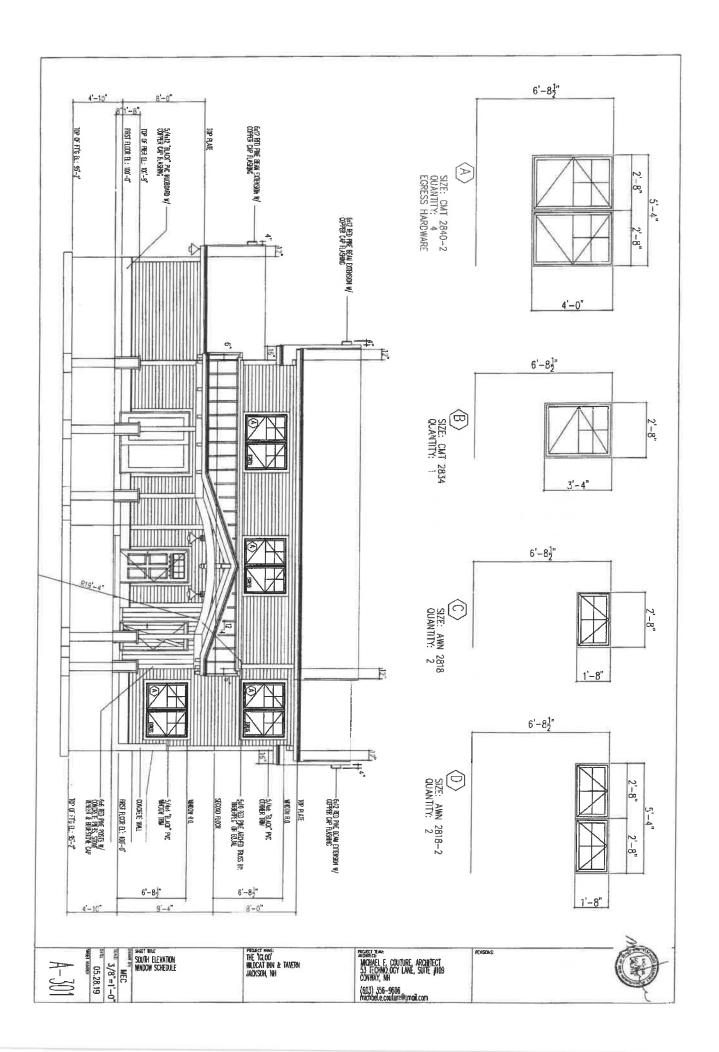
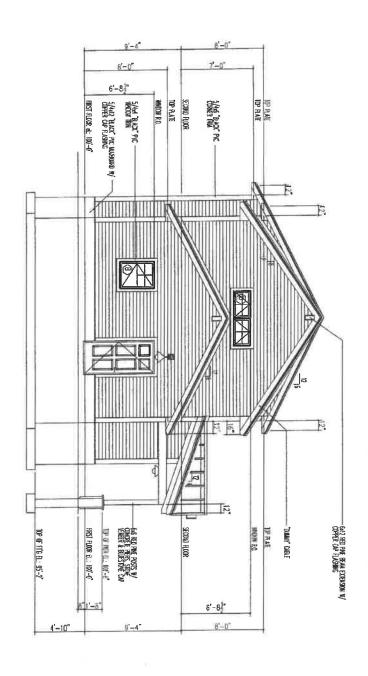
PROJECT MANE: THE "OCLOO" MRDCAT IRN & TAVERN JACKSON, NEE MICHAEL E. COUTURE, ARCHITECT 53 TEDRINGOY LANE, SUITE, FIOS CONWAY, MH (603) 356-9606 michael e. couture tymoal.com

As the members of the ZBA will see from the attached drawings, The Wildcat Inn & Tavern is situated on 2 lots. In addition to moving the Igloo Cottage forward 4 feet we would also like to increase the footprint length by 10 feet to help make it a more spacious and desirable rental unit. In adding 10 feet in length to the building the proposed new footprint would cross the boundary line of the second parcel. Accordingly, we would propose as part of this process the combining of the 2 lots with the Town of Jackson's approval. This step would make this building more conforming.

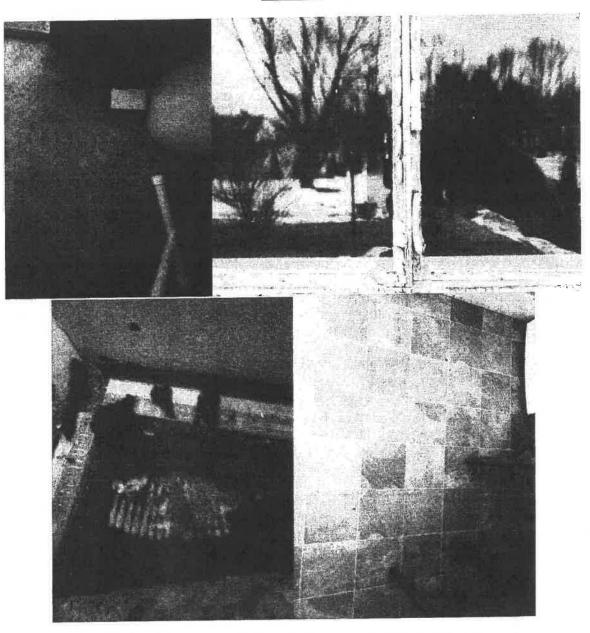
PHOTOS

The results of the analysis of the samples taken reveal that some of the interior linoleum flooring and corresponding adhesive contains asbestos.

Sample # Location		ltem	Result	
1	Roof	Shingle	None	
2	Exterior Window Gla		None	
3	3 Kitchen Li	Linoleum Top	None	
4	Kitchen Adhesive / Leveler		None	
5	Kitchen	Linoleum	None	
6	Kitchen	Adhesive	None	
7	Living Room Closet	Linoleum	None

8	Living Room Closet	Adhesive	None
9	2nd Floor Bedroom Closet	Green Paper	None
10	Bedroom	Sheetrock Composite	None
11	2nd Bathroom	Linoleum	35% Chrysotile
12	2nd Bathroom	Adhesive	2% Chrysotile

- •Asbestos-containing flooring/adhesive was identified on the property as a regulated material that will need to be removed prior to demolition.
- •All asbestos containing materials (ACMs) greater than 1% and regulated asbestos containing materials (RACMs) that will be disturbed by any planned renovation or demolition must be removed prior to disturbance by a licensed NH asbestos abatement contractor in accordance with all local, state and federal regulations.
- •All ACM wastes must be handled and disposed of in accordance with all local, state and federal regulations.
- •Submit NESHAPS notification to NH DES 10 days prior to abatement.
